# Watershed Report: A Year in Moria Camp

November 2017 - November 2018

# Watershed in Moria

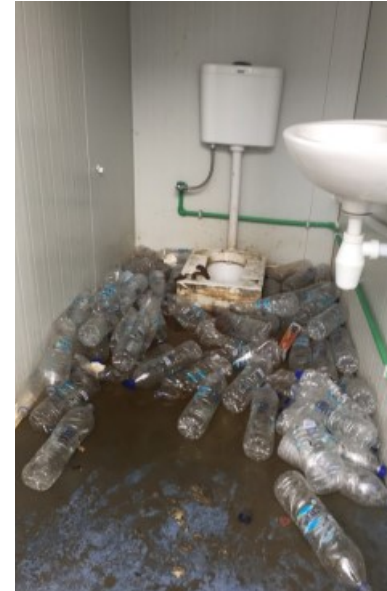
Upon our arrival to Moria in November 2017, we identified a severe shortage of toilet facilities for the number of residents living in the camp, with some facilities being completely inaccessible to the residents. Furthermore, all of the communal toilet facilities in the open area of the camp were in an abysmal state: unclean, unmaintained, and dangerously unhygienic. Once we had conducted a large-scale project to deep-clean and repair the facilities, we could identify which were most in need of refurbishment. Several had leaking floors, rotten wall panels and completely broken fixtures.

First impressions of Moria’s toilets

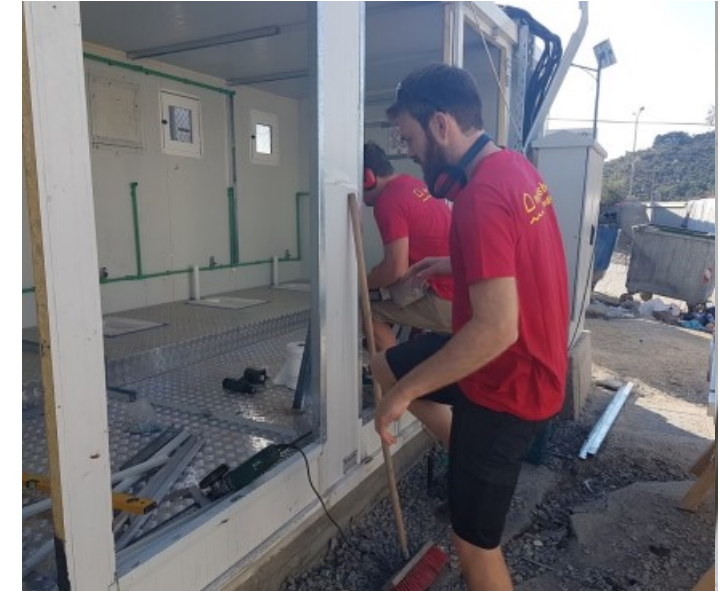
Refurbishing a toilet container after completely gutting the interior of the previously unusable facility

We have completely refurbished six containers which had the most severe problems. We dismantled the units, stripping them down to the bare structure and essentially rebuilding the

containers, not just improving the quality, but in most cases also increasing the quantity of facilities in each unit.

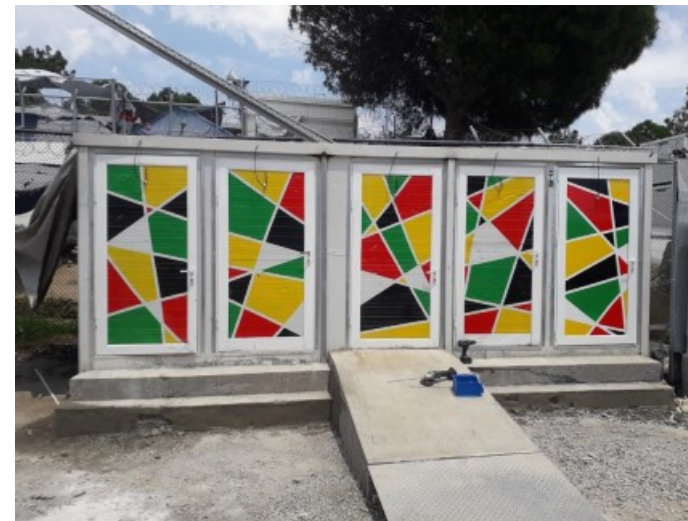
A newly-refurbished WASH container in the “African Section”

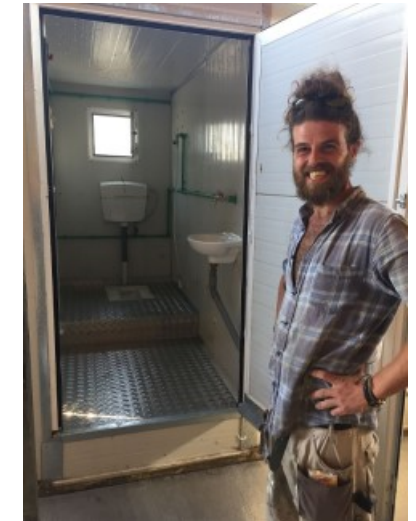
Having gathered an understanding of how the facilities are used by the residents, we have been able to design multifunctional, needs-based solutions; we usually build up to six wet rooms in each unit, each containing a shower, a sink, a squat toilet and a bidet sprayer.

Our standard cubicle design incorporates a toilet, bidet hose, sink and shower

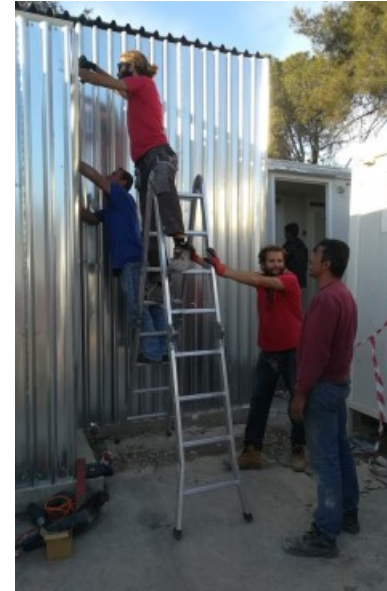
Building a structure to house the boiler which heats water in the shower block

In the Autumn of 2018, we installed an industrial-scale water heater, along with three large hot water tanks, in a new structure we had built alongside the shower block. This system is fueled by olive pellets, a cheap and locally abundant agricultural by-product, and it provides reliable hot water to the 26 showers here for eight hours a day. The custom-built boiler has an output of 200 kilowatts, which is not only much more powerful compared to a standard four kilowatt solar boiler, but also a much more cost-effective and efficient way of heating water, irrespective of the weather.

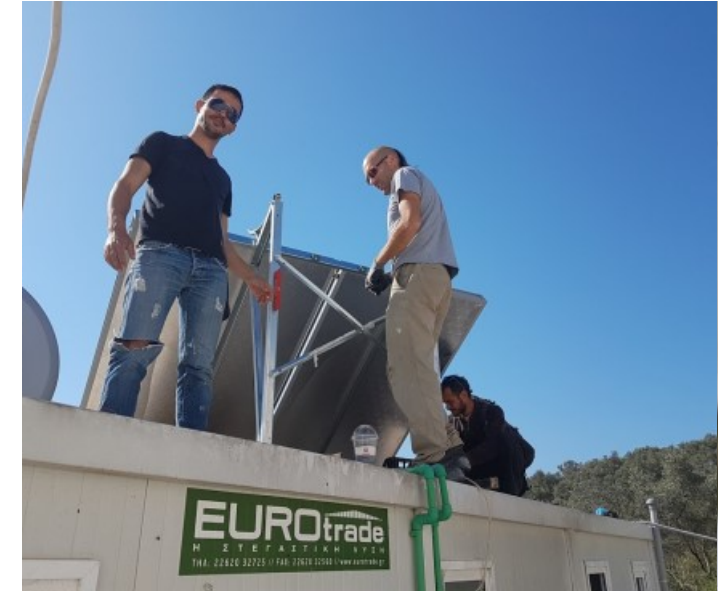
Installing a new solar boiler unit

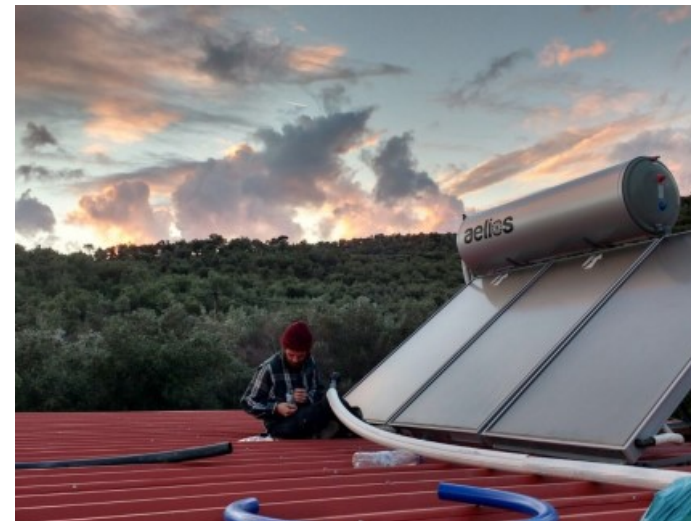
Insulating hot water pipes

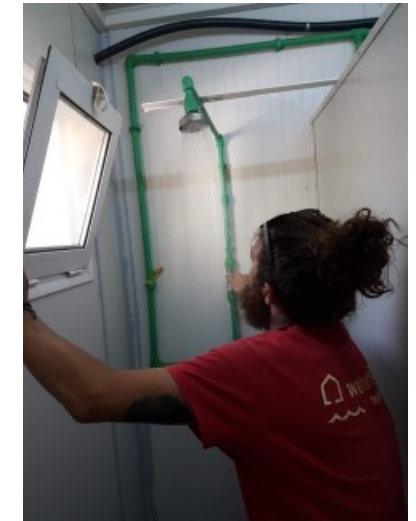
A new shower cubicle in Level Four

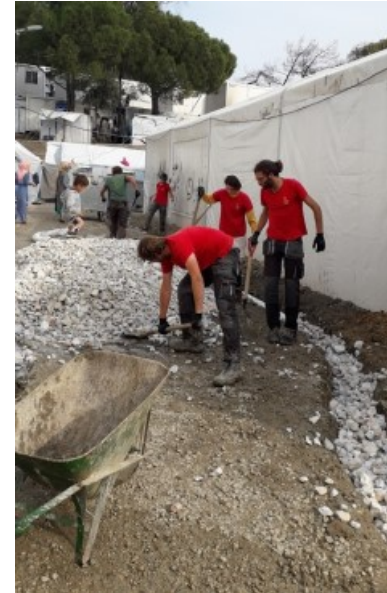
Shovelling gravel to build a French drain

In order to overcome these problems, we have installed 68 metres of 'French drains,' trenches containing a perforated pipe, wrapped with webbing and covered with gravel, so the water seeps through the gravel, into the pipe and is drained away properly. These have been implemented in the most saturated areas around the camp. Furthermore, we have dispersed over 120 tonnes of gravel, which covers a surface area of over 600 m<sup>2</sup>, in order to remedy rain-soaked ground, cover sewage leaks and ensure a more hygienic environment. We also installed various storm drains and gullies, which prevents the ground from becoming waterlogged, as rain water is directed away.

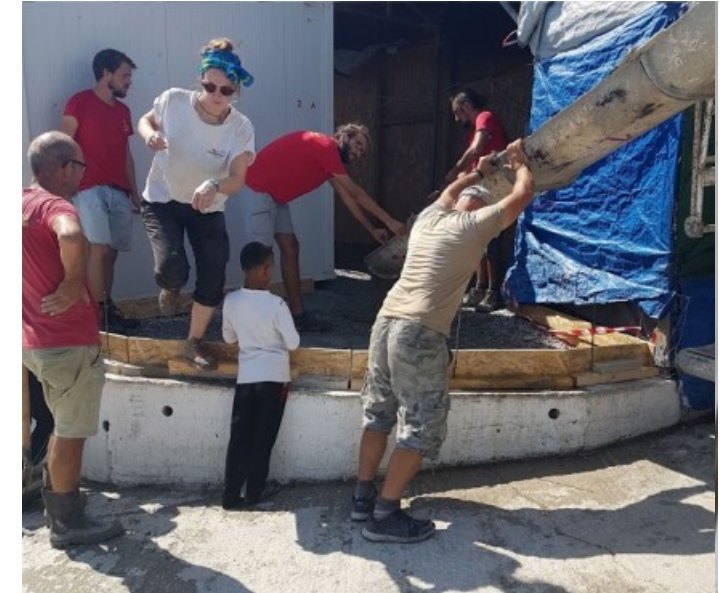
Pouring concrete for a new wash pad

Finally, we designed communal spaces that cater to the domestic needs of the residents, known as 'wash pads.' These concrete slabs are gently sloped towards a central drain, so that any water hitting the ground is directed away, rather than flooding the surrounding area. They are fitted with sinks and taps for collecting water, personal hygiene, ritual washing, laundry

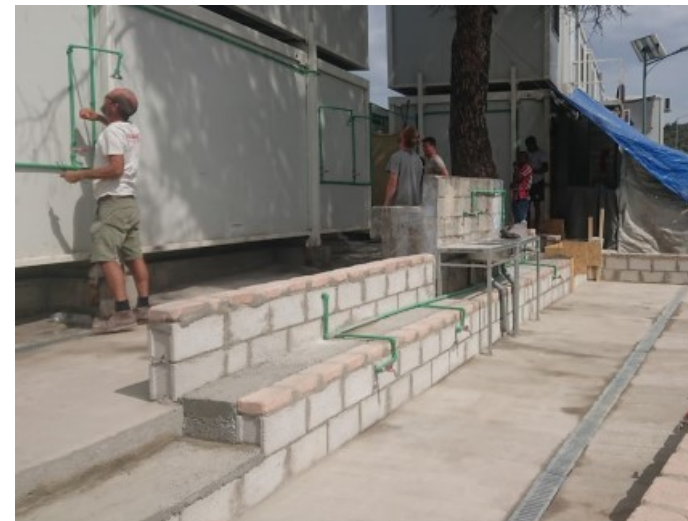
Adding showers to the camp's largest wash pad

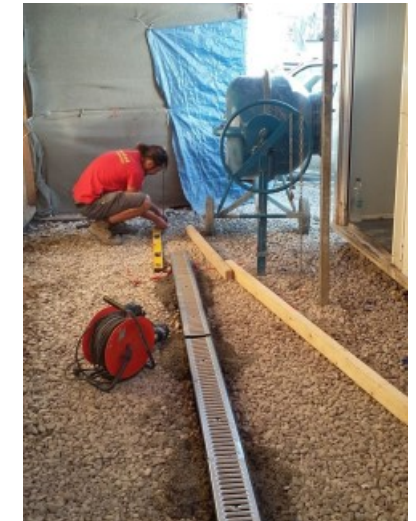
Checking the slope on a drainage gully

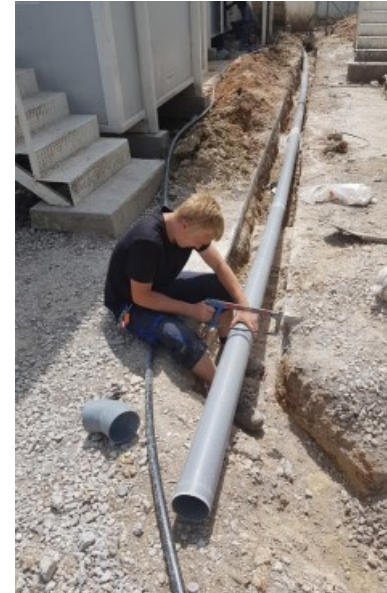
Laying a sewage pipe

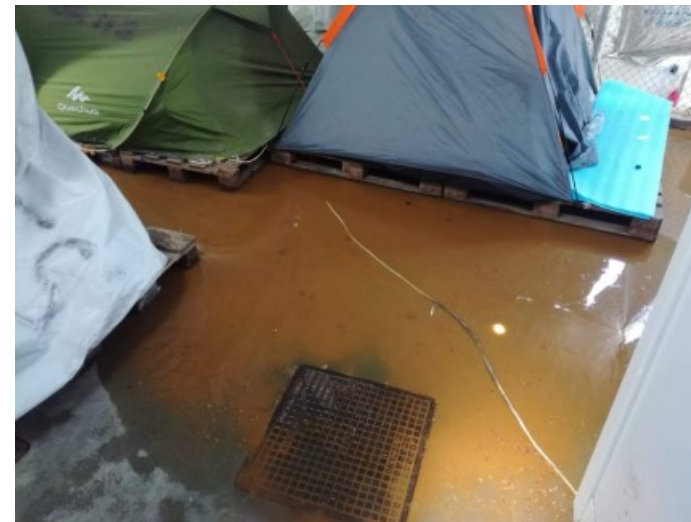
In one month, it is still not uncommon for us to respond to a dozen sewage blockages, which often result in raw sewage flooding common or residential areas.

One of the more severe sewage leaks we have seen, on Level Three

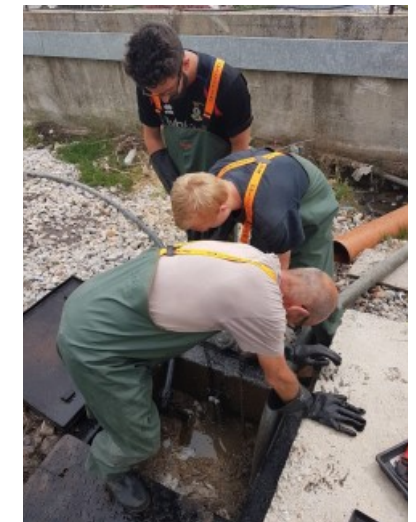
Diving in to service the main sewage pump

Over the course of the year, we have repaired and reinstalled five sewage pumps, and have unblocked or repaired countless pipes, in order to ensure the system is operating as effectively as possible, which unfortunately still isn't a sufficient capacity and trucks are required to take sewage away every single day. Overall, we have installed over 350 metres of new water supply pipes and over 275 metres of sewage pipes. This has been during a number of different projects in the common area of the camp. For example, we replaced pipes in areas that

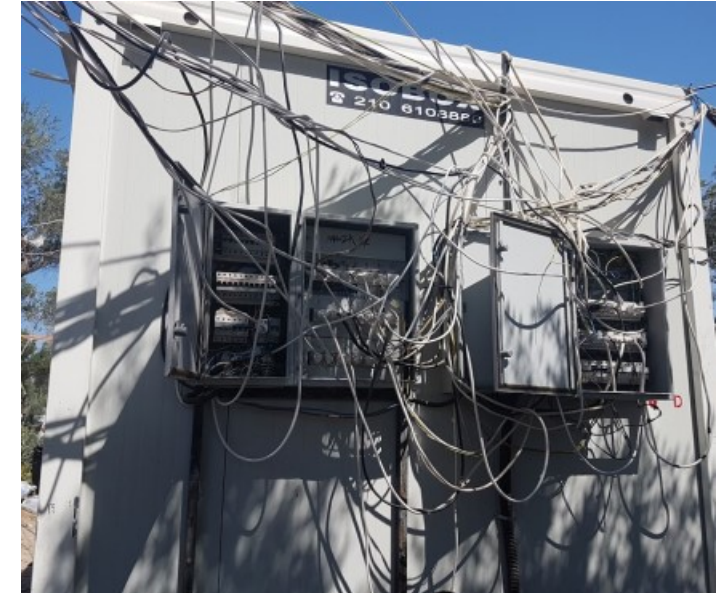
Due to overpopulation in the camp, the existing electrical systems are often overloaded, and numerous unsafe connections are made all over Moria, as residents connect up their tents themselves.

A maze of electrical connections running to tents

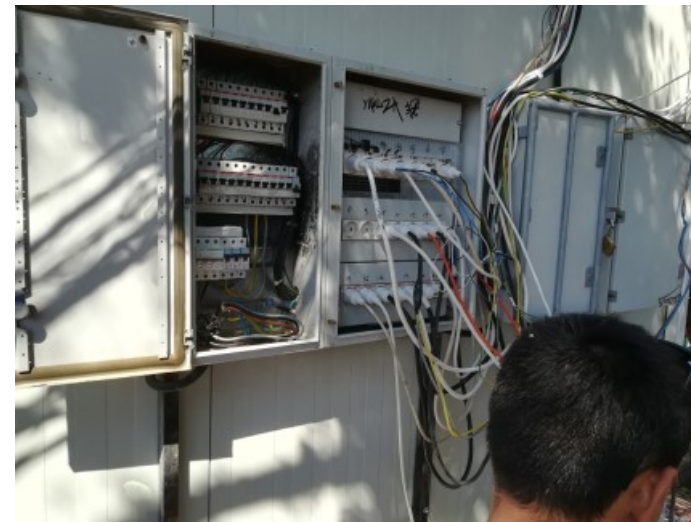
A newly-installed electrical box

After conducting an electrical assessment of the camp in February 2018, our electrical team have since made numerous repairs to the system; trying to ensure that all the connections are safe, rewiring fuse boxes and installing cages (to lock them up and avoid further damage, unsafe connections and electrocution hazards).

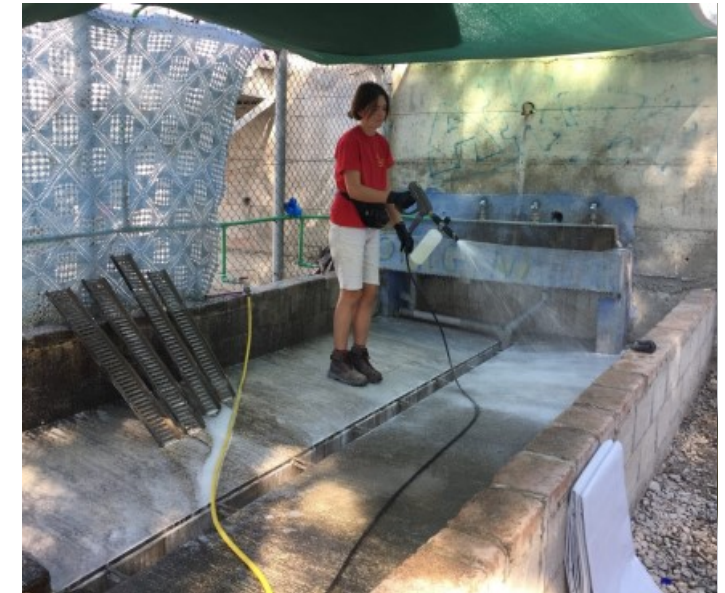
Cleaning and servicing one of our ‘wash pads’

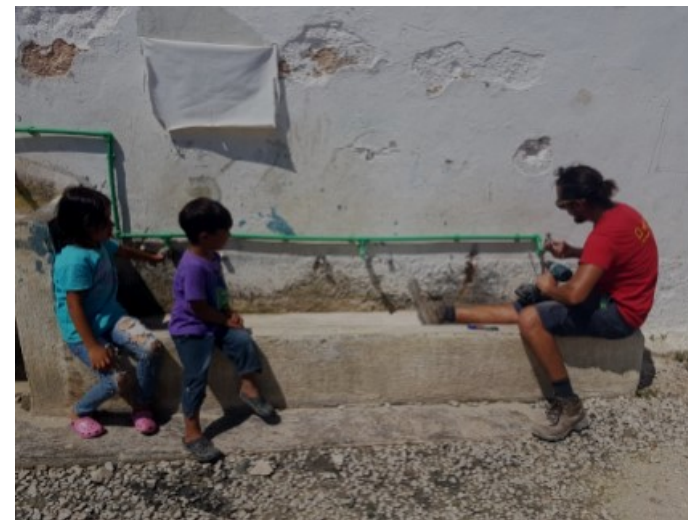
Replacing taps on some outdoor sinks

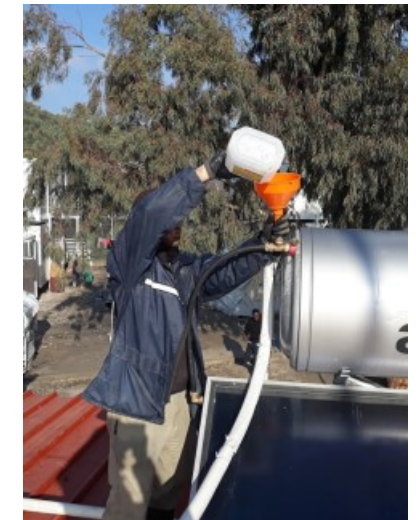
Topping up the glycerine in a boiler
